MicroSmart Pentra FC5A BUG REPORT

Type: FC5A-D16RK1/-D16RS1/-D32K3/-D32S3

Firmware Version : 210 (Included in WindLDR version 5.32)

LogicEngine Version : 110 or 120

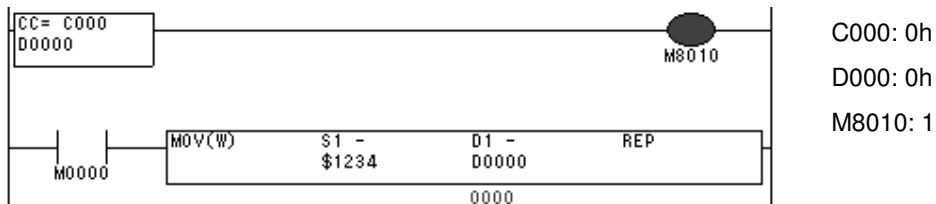
CC (Counter Comparison) instruction in the FC5A firmware version 210 in conjunction with LogicEngine version 110 or 120 does not operate correctly.

1. Create the following ladder program in WindLDR.

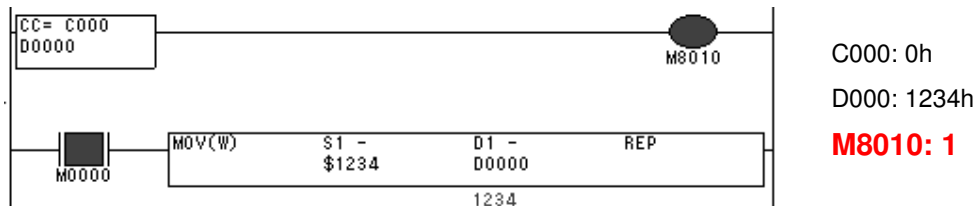
2. Turn on M0000. (1234h is moved to D0000.)

M8010 is turned on even though D0000 and C000 are not equal.

This problem occurs when the preset value of the CC(Counter Comparison) instruction is D0-D1999 or D8000-D8399.

This is a bug in MicroSmart Pentra FC5A slim CPU firmware version 210, which is included in WindLDR version 5.32.

This bug is now fixed with WindLDR version 5.33 and FC5A firmware version 2.11.
